AVIATION INVESTIGATION REPORT
A04H0001

LOSS OF CONTROL

GEORGIAN EXPRESS LTD.
CESSNA 208B CARAVAN C-FAGA
PELEE ISLAND, ONTARIO
17 JANUARY 2004

Report Number A04H0001

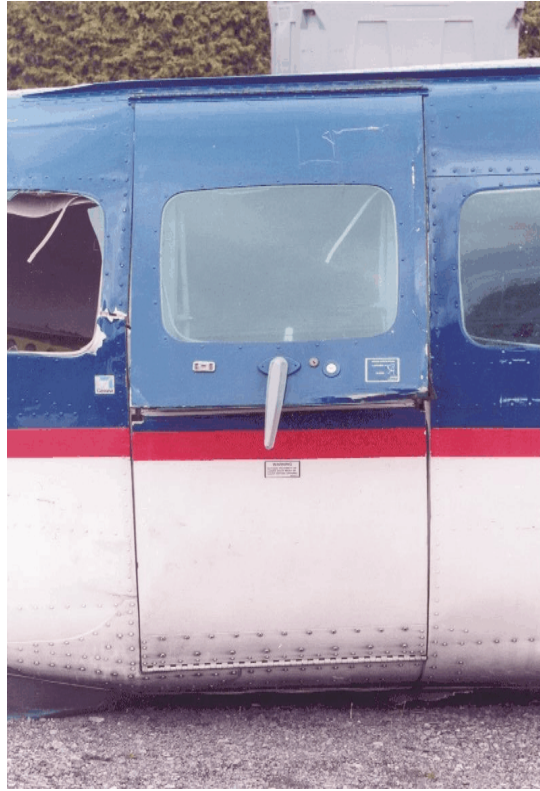
Photo 3. Exterior view of cabin passenger door

TC reviewed a Georgian Express Ltd. safety features card in June 2000 and issued a “meets standards” letter to Georgian Express Ltd. However, the safety features card retrieved from the occurrence aircraft was an Air Georgian safety features card. This card was reviewed by TSB investigators against TC’s Commercial Air Service Standard 723.39(4) for content, accuracy, and clarity. Some required safety information was missing, specifically information about stowing carry-on baggage and about brace positions for adults holding infants. In addition, pictorial instructions regarding the passenger restraint systems and the operation of the emergency exits were unclear and difficult to understand.

Although this was not a survivable accident, the inadequate information and instructions provided by the safety features cards and placards could impede a timely and safe evacuation in an emergency situation.
